FINAL DESIGN

SIGN PROJECT

Ardmore, Oklahoma FEC

The  
Clubhouse

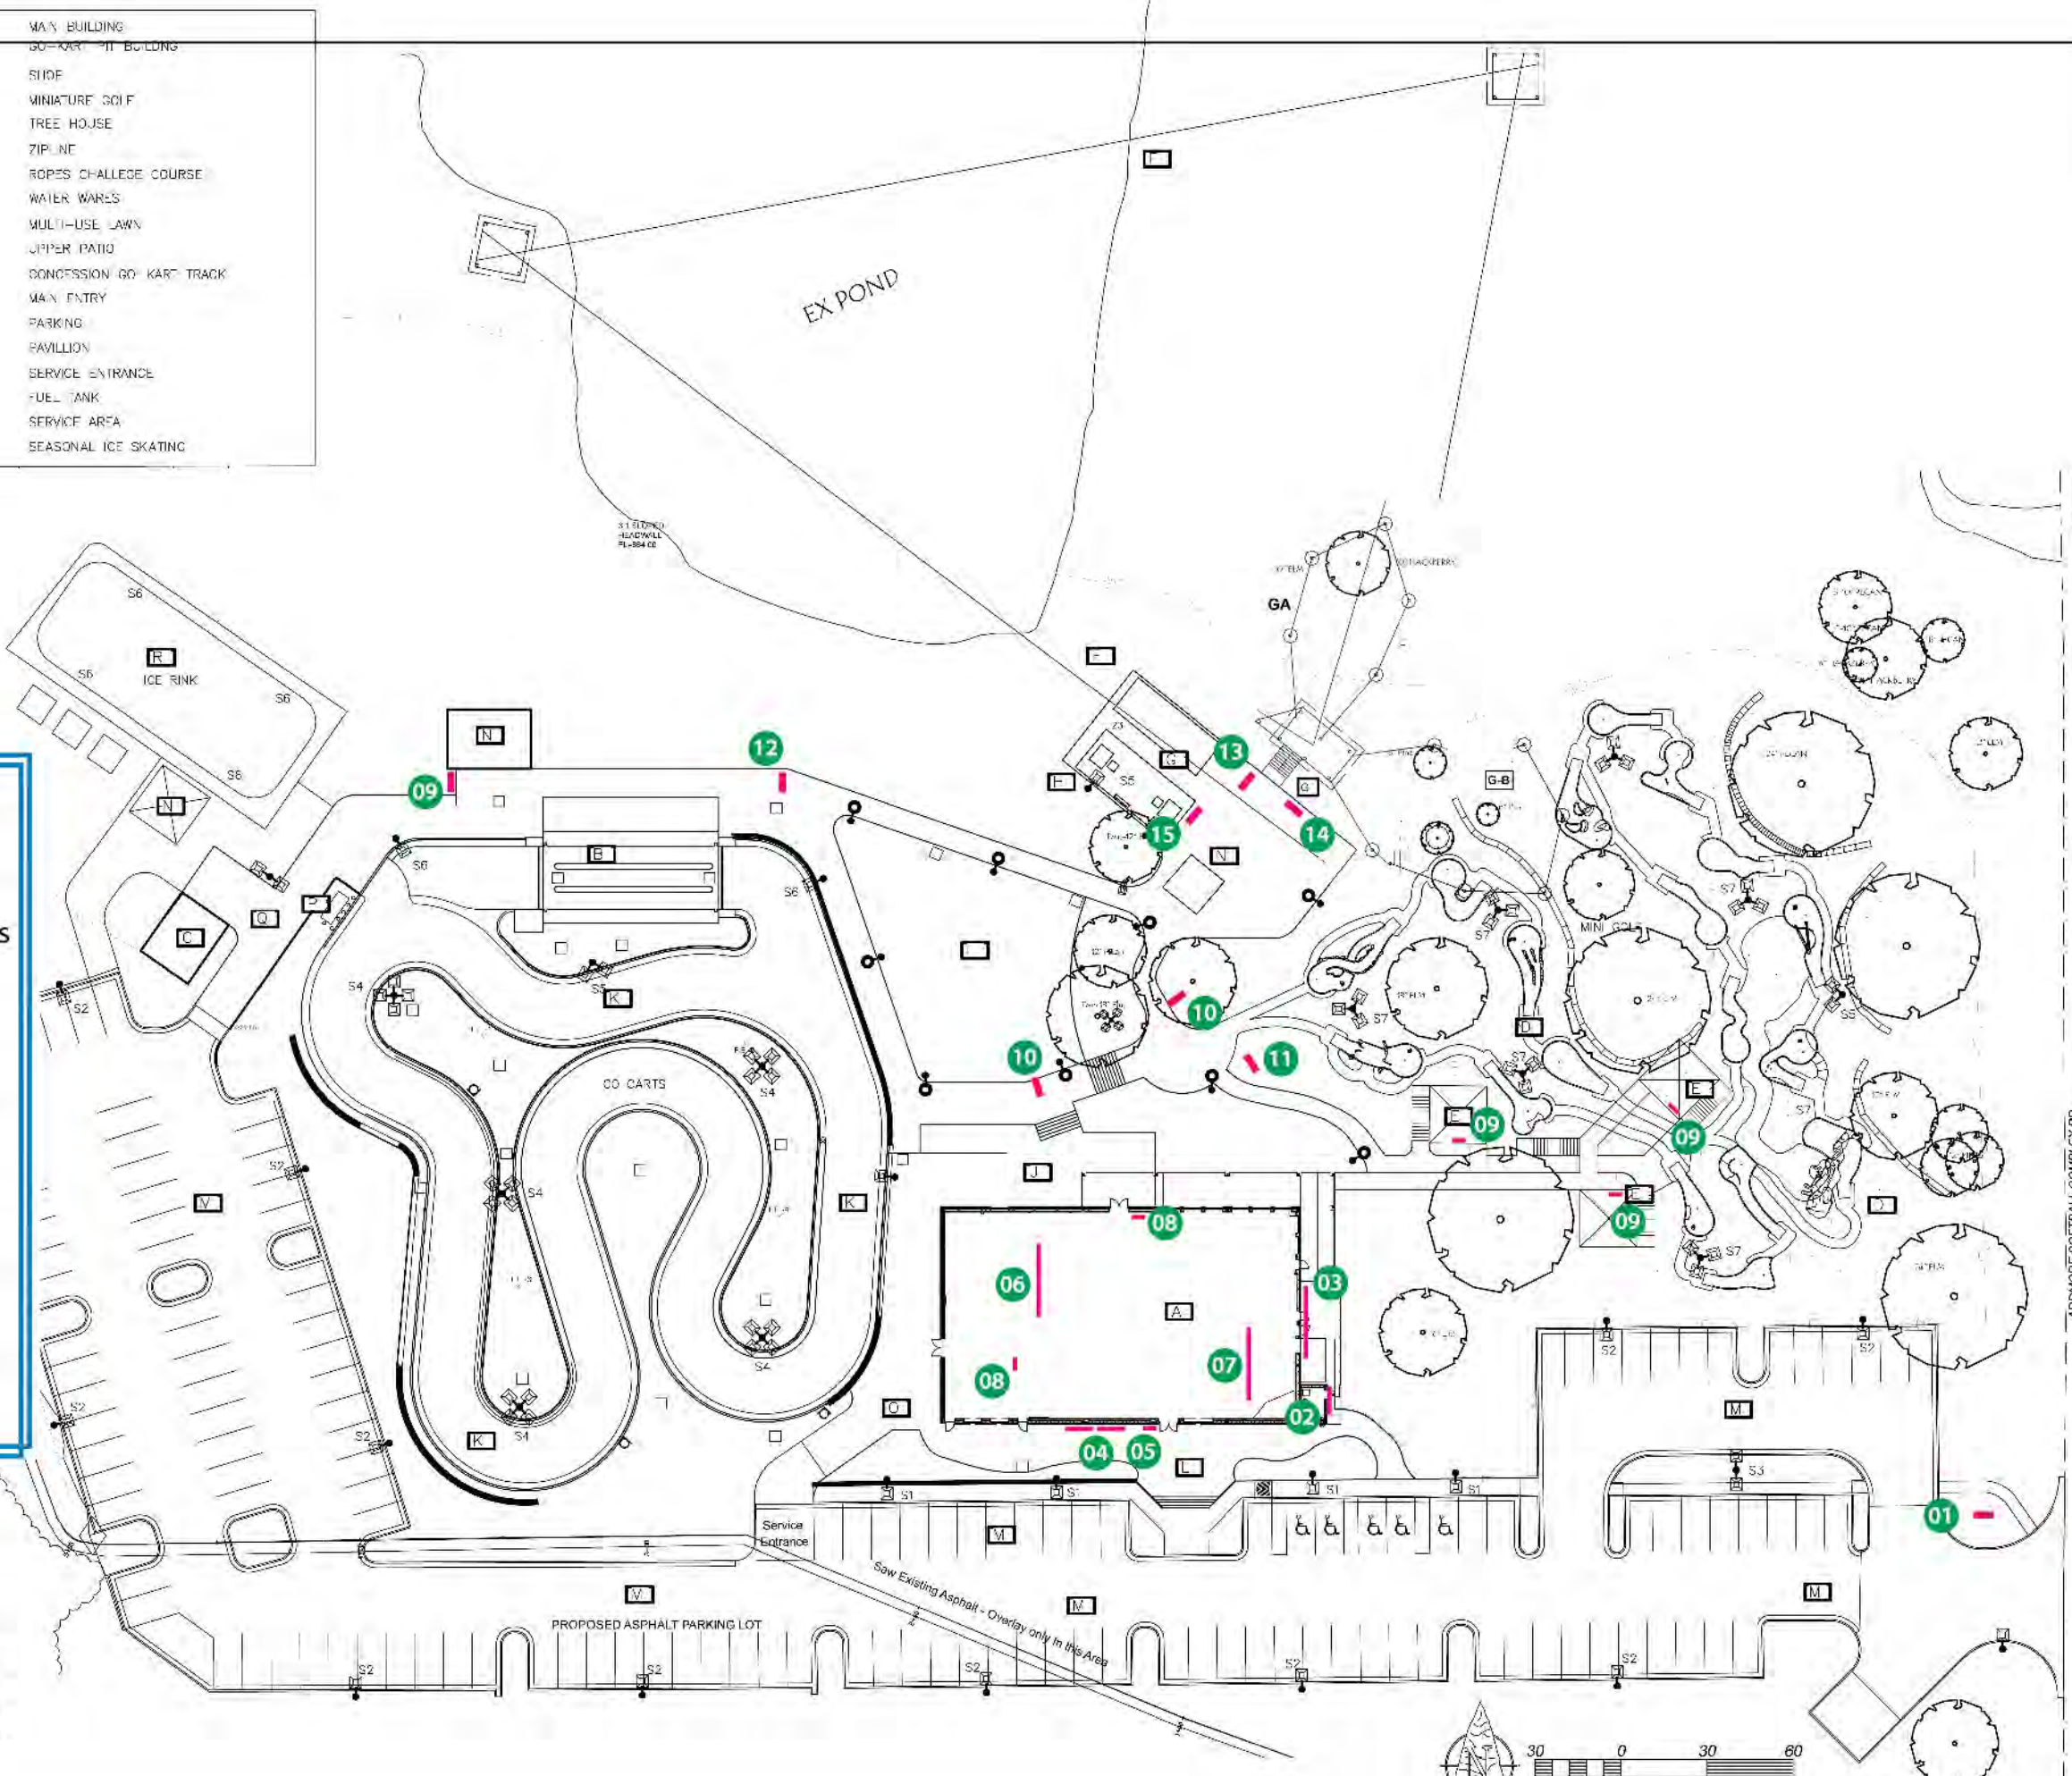
**PROJECT SIGN PLAN**

| A | WAY BUILDING |
| B | GO-KART PIT BUILDING |
| C | SLIDE |
| D | MINIATURE GOLF |
| E | TREE HOUSE |
| F | ZIPLINE |
| G | ROPES CHALLENGE COURSE |
| H | WATER WARS |
| I | MULTI-USE LAWN |
| J | UPPER PATIO |
| K | CONCESSION GO-KART TRACK |
| L | MAIN ENTRY |
| M | PARKING |
| N | PAVILLION |
| O | SERVICE ENTRANCE |
| P | FUEL TANK |
| Q | SERVICE AREA |
| R | SEASONAL ICE SKATING |

- 01 MAIN MONUMENT SIGN
- 02 BUILDING LOGO
- 03 BUILDING NAME SIGN
- 04 BUILDING PROMO PANELS
- 05 RULES
- 06 CUSTOMER SERVICE
- 07 FOOD SERVICE
- 08 WAYFINDING INTERIOR
- 09 TREE HOUSE ID
- 10 WAYFINDING EXTERIOR
- 11 GOLF SIGN
- 12 RACEWAY KART SIGN
- 13 FLIGHT LINE SIGN
- 14 EAGLE LANDINGS SIGN
- 15 WATER WARS

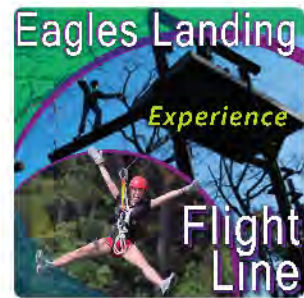
9'-0" SQUARE IMAGE PANELS  
HIGH-GLOSS BLACK POWDER-COAT  
FINISH 1/4 THICK ALUMINUM PANELS  
DIGITAL PRINTS APPLIED

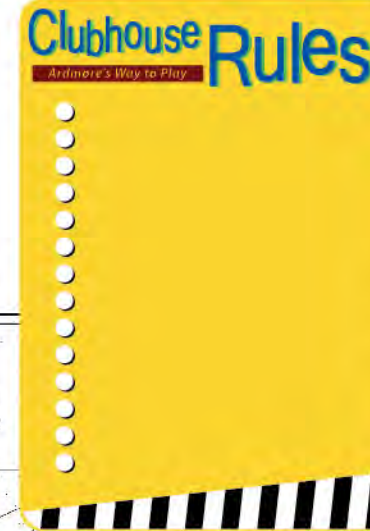
DETAIL

36" x 60" RULES SIGN  
1/4 THICK ALUMINUM PANEL  
DIGITAL PRINT APPLIED

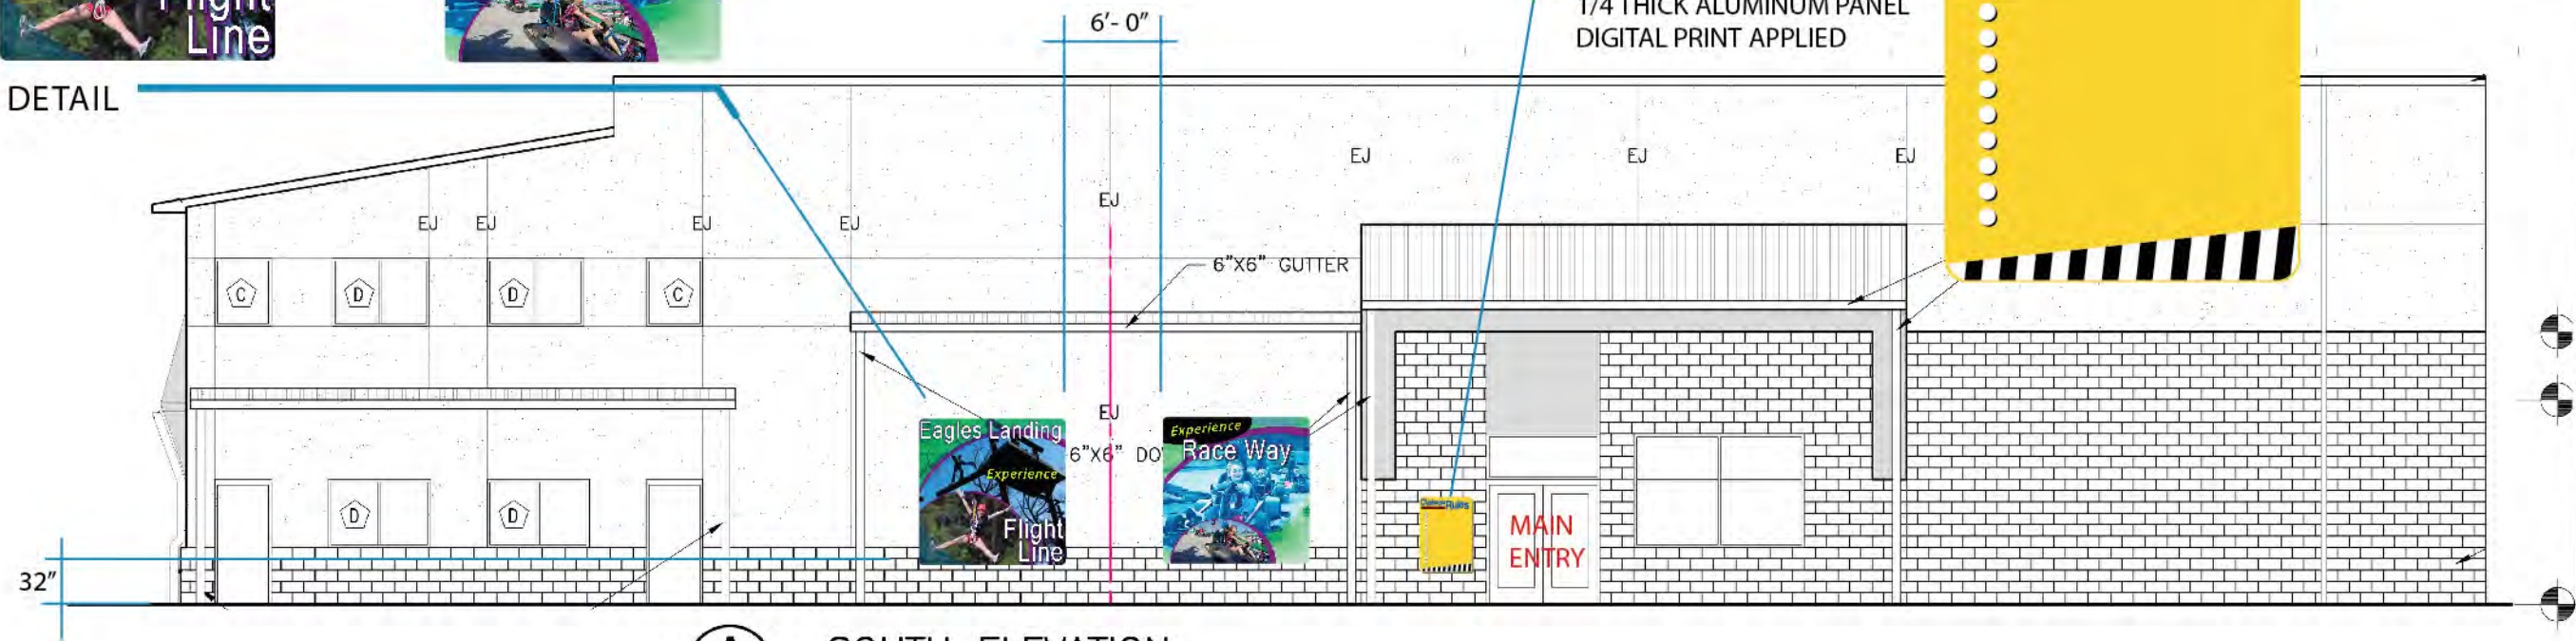
**A** SOUTH ELEVATION  
A500

12'-0" Dia.  
REAR ILLUMINATED LOGO  
CIRCULAR SIGN. ART ON  
TRANSLUCENT PANEL, LIT  
FROM BEHIND

EIFS  
METAL ROOF BEYOND  
PRE FINISHED ALUM METAL  
BEYOND  
CMU - PAINTED  
FENCE NOT SHOWN FOR  
CLARITY

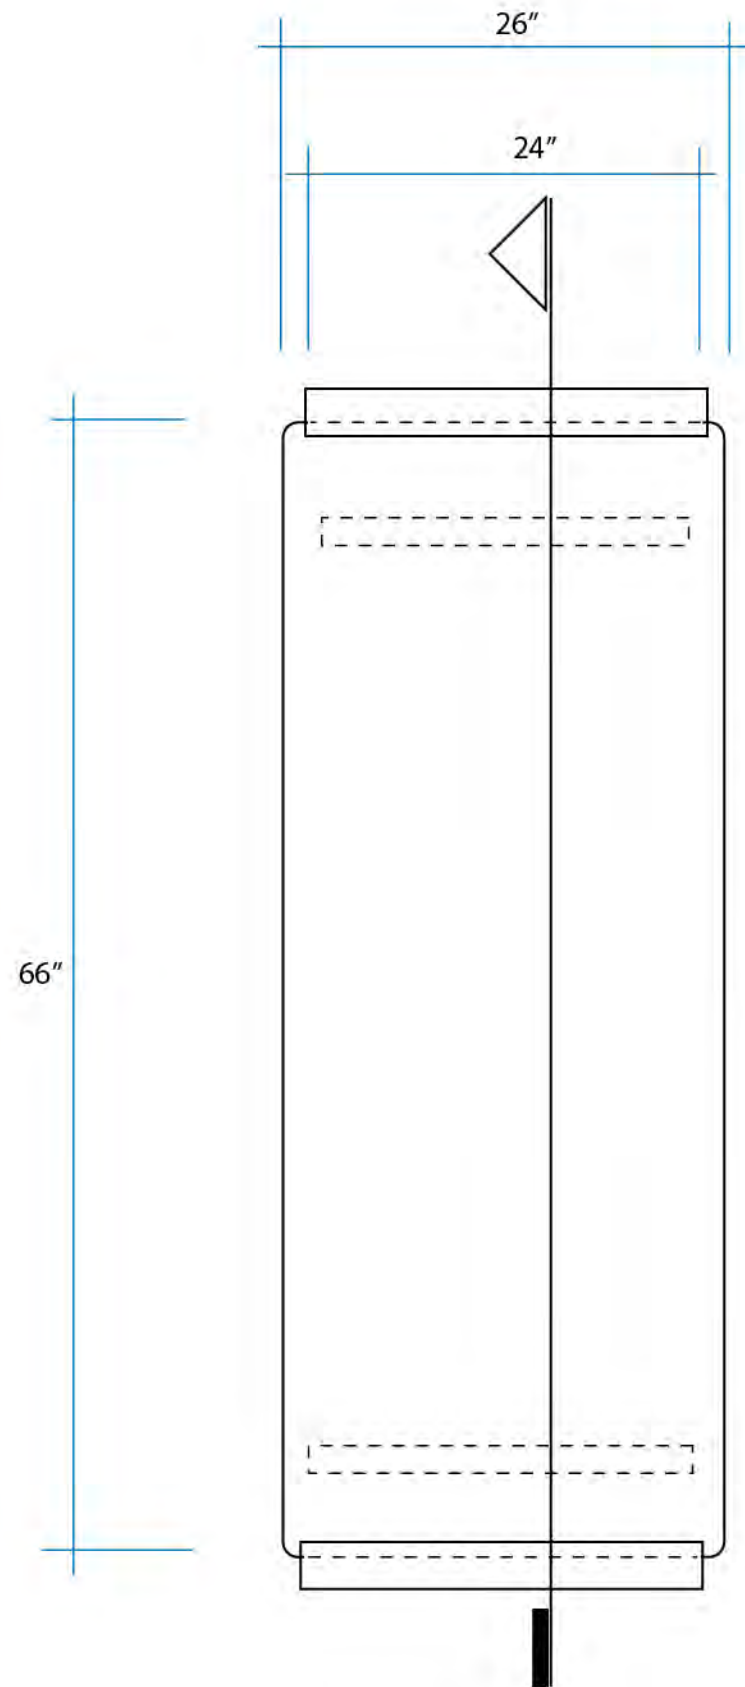
FRONT VIEW

ADHESIVE ATTACH HANGER  
CLEAT AND BLOCKING

1/4 PAINT FINISHED ALUMI-  
NUM WITH GRAPHICS  
APPLIED ONE SIDE

WOOD TRIM TOP &  
BOTTOM TO BE  
STAINED AND  
FINISHED  
HARDWOOD

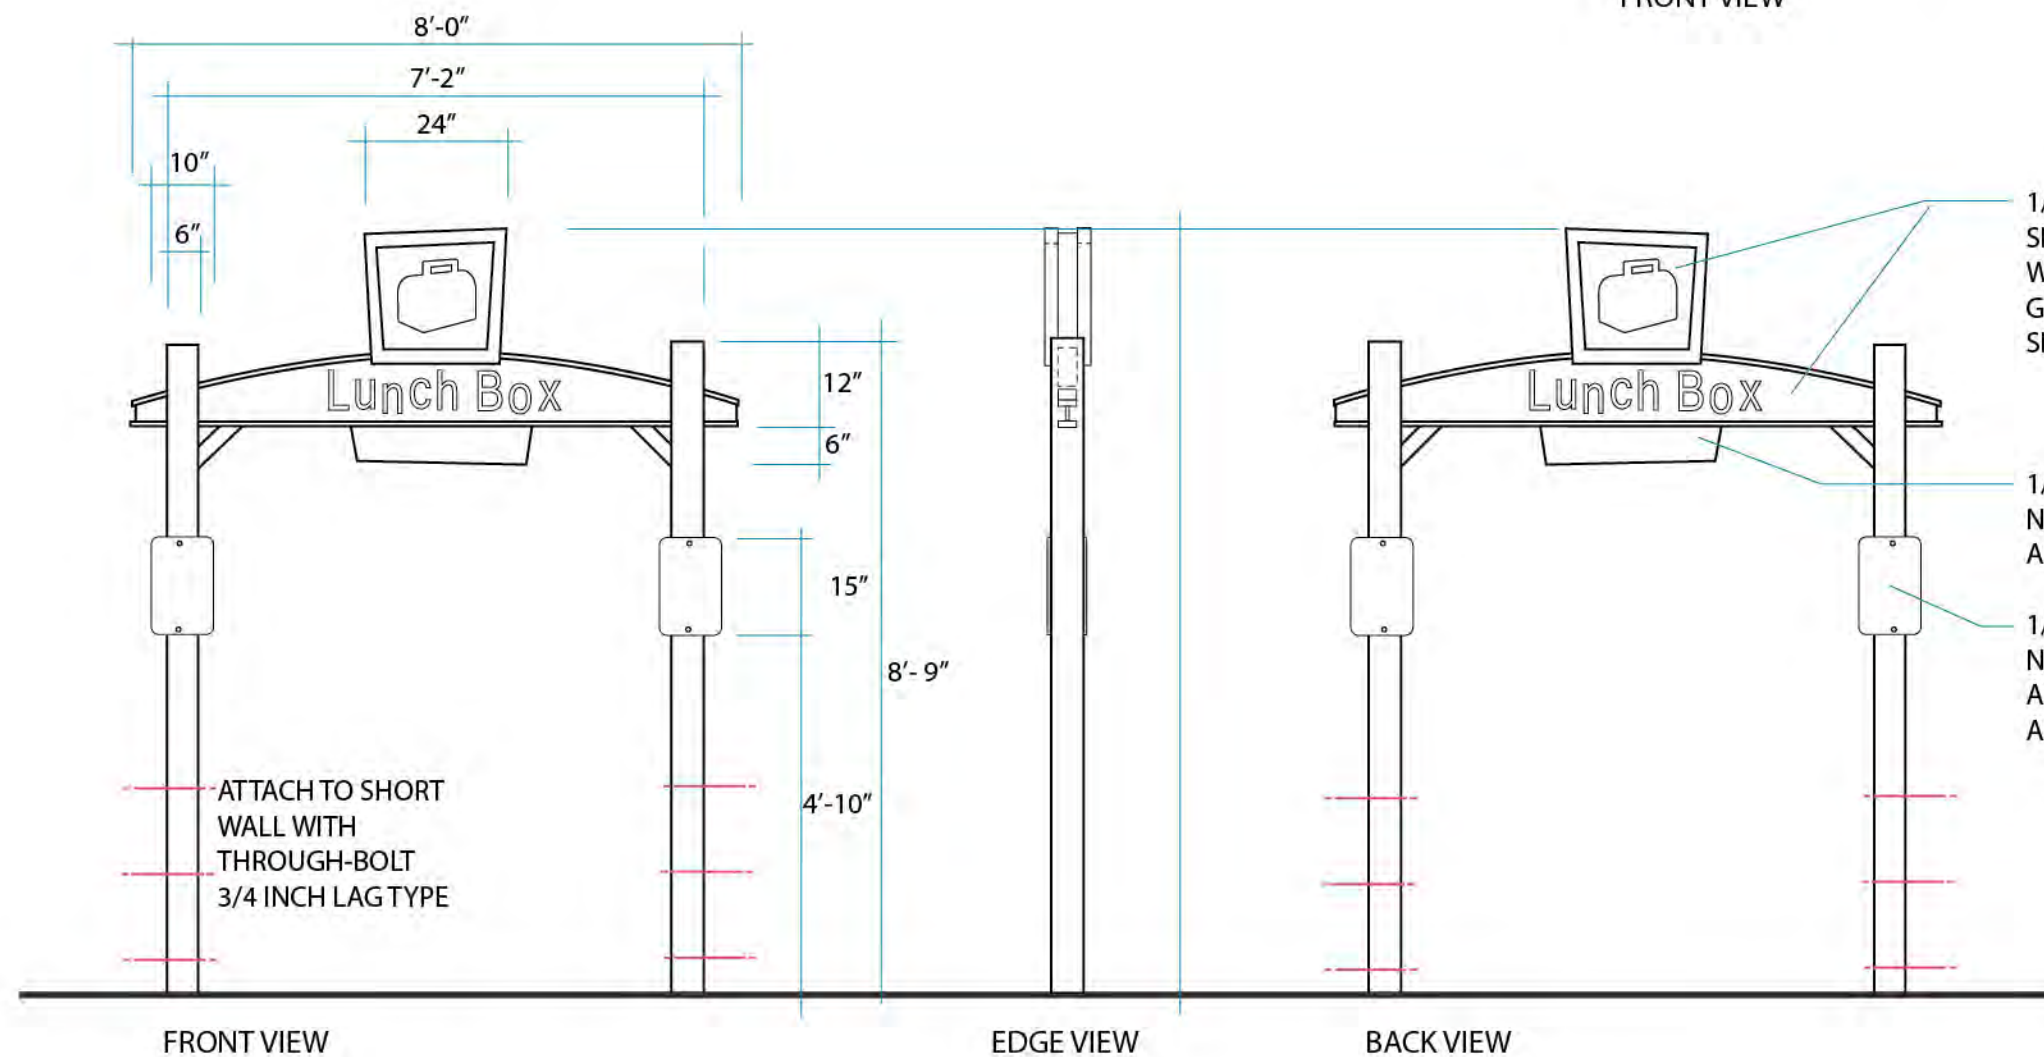
FRONT VIEW

GROUND MOUNTED  
LIGHTS TO ILLUMINATE  
SIGN. TWO SIDES  
BY OTHERS

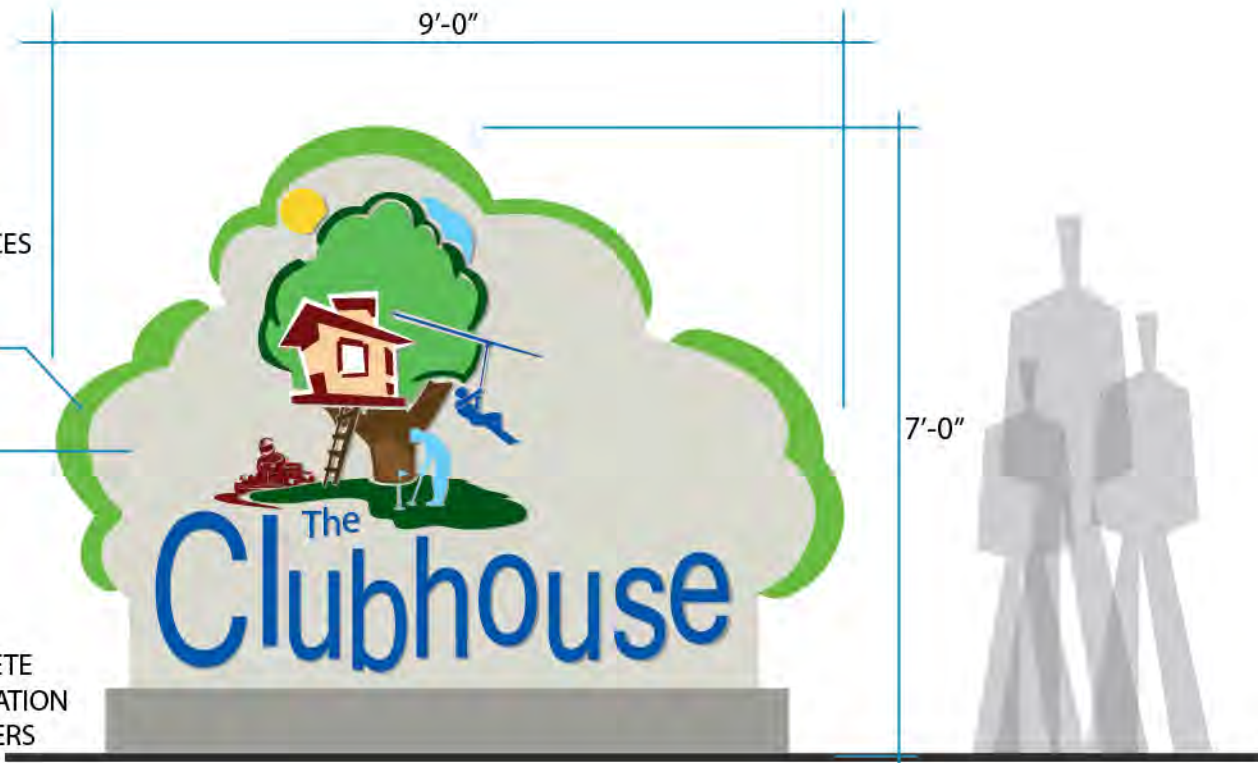
FRONT VIEW

CONCRETE  
FOUNDATION  
BY OTHERS

IDENTICAL SIZE LOGO  
BOTH SIDES

CUT-OUT 3-D LOGO ELEMENTS  
APPLIED TO SIGN FACE
